# REPORT

**18213 PRO CARBON**

Type	<b>SUV</b>
Make	<b>BMW</b>
Model	<b>X6</b>
Engine capacity [ccm]	<b>2998</b>
Power [kW]	<b>279</b>
VIN	<b>XXXXXXXXXXXXXXXXXXXX</b>
Fuel Type	<b>Gas</b>
Year of production	<b>2024</b>
Mileage	<b>45.000 km</b>
Paint color	<b>Black metallic</b>
Paint type	<b>Original manufacturer's paint</b>
Number of owners	<b>1</b>
Paint condition	<b>Minor scratches on the driver's door</b>
Service history	<b>No accidents</b>
Additional comments	<b>No visible body and paint repairs</b>
First registration	<b>01.01.2024</b>
Windows condition	<b>Original manufacturer's windows</b>
Painting history	<b>Fully original paint</b>

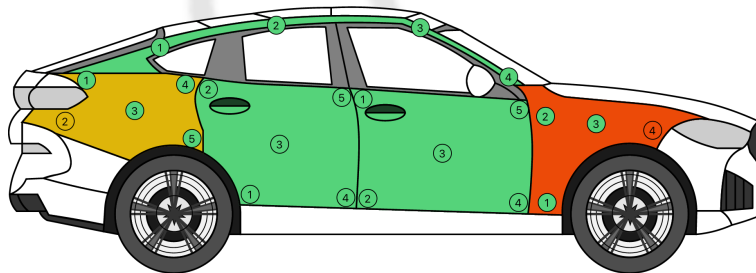
RIGHT SIDE											
	Coating	Minimum	Maximum	Medium	1.	2.	3.	4.	5.	6.	7.
right front fender/ bumper	Fe	83	455	176	83	83	83	455	-	-	-
right front door	Fe	83	84	83	83	84	83	83	83	-	-
right rear door	Fe	84	84	84	84	84	84	84	84	-	-
right pillar	Fe	84	85	85	85	85	85	84	-	-	-
right rear fender/ bumper	Fe	85	231	115	86	231	86	85	85	-	-

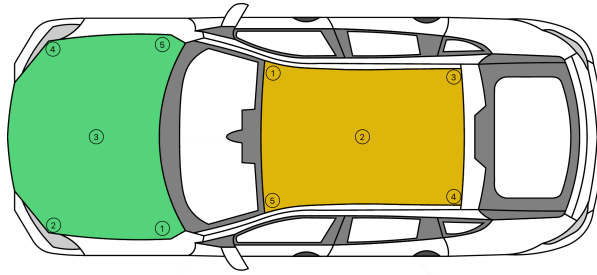
TOP											
	Coating	Minimum	Maximum	Medium	1.	2.	3.	4.	5.	6.	7.
hood/bonnet	Fe	88	90	89	88	90	89	88	88	-	-
roof	Fe	227	233	229	233	229	229	227	227	-	-

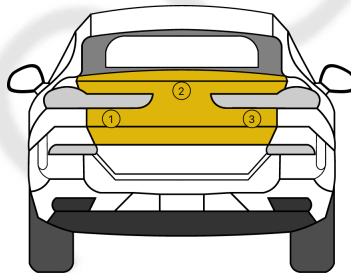
BACK											
	Coating	Minimum	Maximum	Medium	1.	2.	3.	4.	5.	6.	7.
trunk/boot	Fe	226	228	227	228	226	226	-	-	-	-

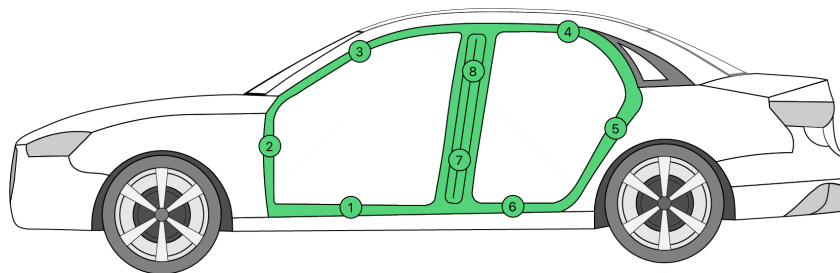
## PAS: general interpretation, internal body parts

LEFT SIDE												
	Coating	Minimum	Maximum	Medium	1. 8.	2. 9.	3. 10.	4. 11.	5. 12.	6. 13.	7. 14.	
Left side	Fe	85	86	85	86 85	86 -	86 -	85 -	85 -	85 -	85 -

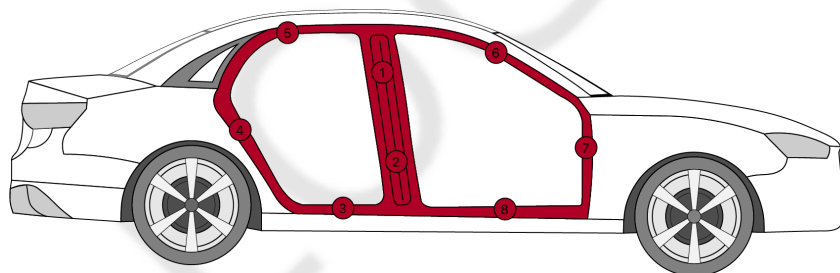
RIGHT SIDE												
	Coating	Minimum	Maximum	Medium	1. 8.	2. 9.	3. 10.	4. 11.	5. 12.	6. 13.	7. 14.	
Right side	Fe	451	800	496	800 451	454 -	453 -	453 -	452 -	451 -	451 -
